Quality analysis of steel billets based on crack defects from magnetic particle inspection (MPI)

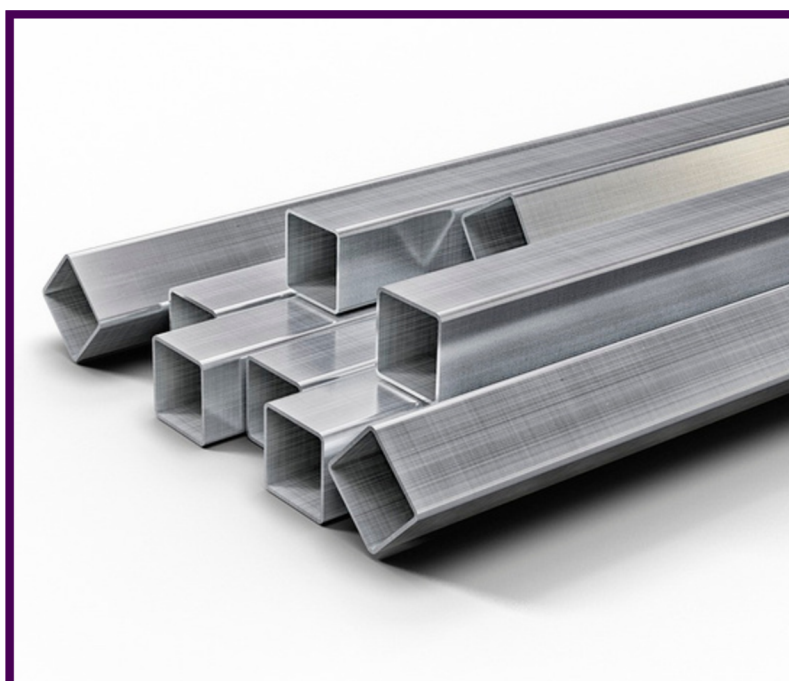
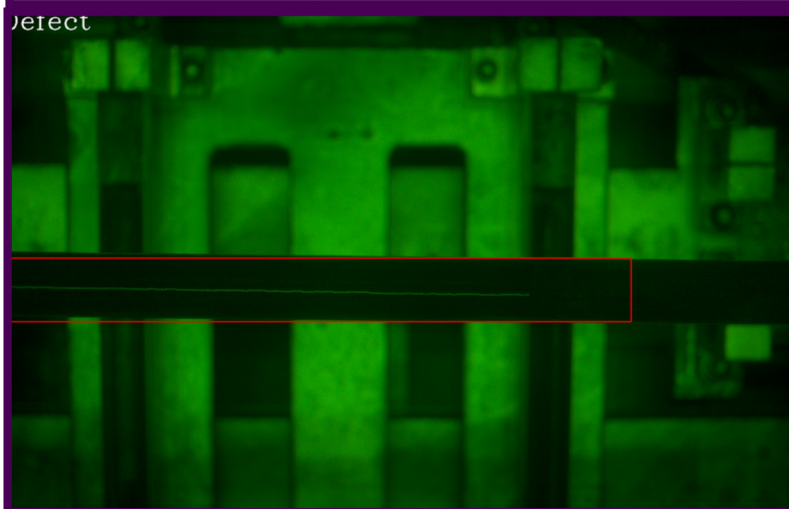
- DAI's MV system was integrated to the automation inspection system to capture and analyse results from MPI.
- Cameras capture images of all surfaces of steel billets every 300 mm.
- Images sent to DAI's MV system for processing.
- Results are then sent downstream using PLCs for further activities.

- Auto detection of defects significantly reduces analysis time of images.
- MV system for MPI processes all the camera images within 1 seconds and send results for operator to view and triggers an alert if there are defects.
